CASE STUDIES

CASE STUDY #1	BOOMER CREEK TRIBUTARY IN WATERLOO REGION
CONCERN	<ul style="list-style-type: none"> • streambank erosion and poor vegetation cover • 35 cattle pastured on Farm A • 35 cattle pastured on Farm B
LANDOWNER	<ul style="list-style-type: none"> • two adjoining landowners • both run mixed cattle/hog operations • culvert crossings were already in place on both farms (i.e., prior to fencing)
ACTION TAKEN	<ul style="list-style-type: none"> • consulted Grand River Conservation Authority • fenced 720 m (2400 ft.) between 1999 and 2001 • installed, in total, an additional 1200 m (4000 ft.) page wire fence • created 10 ft. buffers on either side of creek on both farms • established one row of trees in the buffer on the north side of the creek on both farms • did not plant other side of the creek into trees • planted a mix of white ash, silver maple, red maple, sugar maple and black cherry saplings at 3 m (10 ft.) spacing

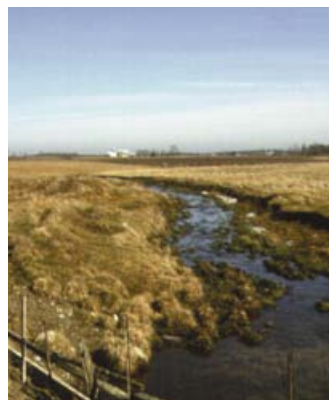
Shown here is the Boomer Creek Tributary before fencing.

A few months after fencing in 2002, trees were established on the north side, as evidenced by the white tree guards.

BENEFITS TO DATE	<ul style="list-style-type: none"> • since the cattle have been restricted from the creek, the channel has become noticeably narrower and deeper • grass cover has re-established itself on the streambanks, and erosion is no longer evident • tall grasses now shade the creek and filter

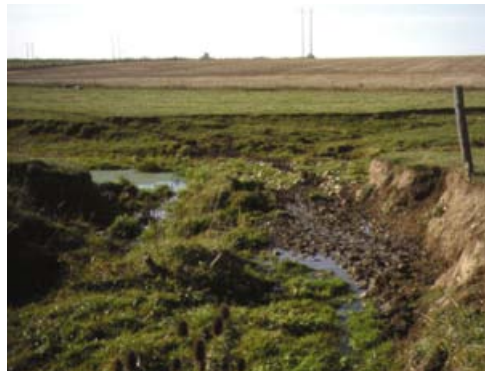
Secondary creek before fencing. Note severe bank erosion.

Several months after fencing.

- two creeks cut through this pasture
- 25 cow-calf pairs had unrestricted access
- streambanks were severely eroded in several locations

- built 1740 m (5800 ft.) of five-strand high-tensile fence in 2000, with the help of family members
- constructed three bed-level crossings (reinforced by concrete slats)
- installed two nose pumps in each of the three pasture sections as alternative water sources
- restricted cattle from the crossing area, except when they are rotated into the next pasture
- retired 2.5 ha (6.25 ac) of land to buffer/trees
- established green ash and bur oak saplings as well as white pine, white spruce, and white cedar seedlings in the buffer on both sides of the creek
